STATE OF CALIFORNIA
DEPARTMENT OF TRANSPORTATION
NEW TECHNOLOGY & RESEARCH PROGRAM
OFFICE OF INFRASTRUCTURE RESEARCH

**DEVELOPMENT OF QUICK CHANGE
BREAKAWAY SIGN SUPPORT SYSTEMS TO BE
USED AS AN ALTERNATIVE TO INSTALLING
SMALL WOOD POSTS IN AUGERED HOLES IN
SOIL**

1. REPORT NO. FHWA/CA/TL-98/14	2. GOVERNMENT ACCESSION NO.	3. RECIPIENT'S CATALOG NO.	
4. TITLE AND SUBTITLE Development Of Quick Change Breakaway Sign Support Systems To Be Used As An Alternative To Installing Small Wood Posts In Augered Holes In Soil.		5. REPORT DATE NOV. 2000

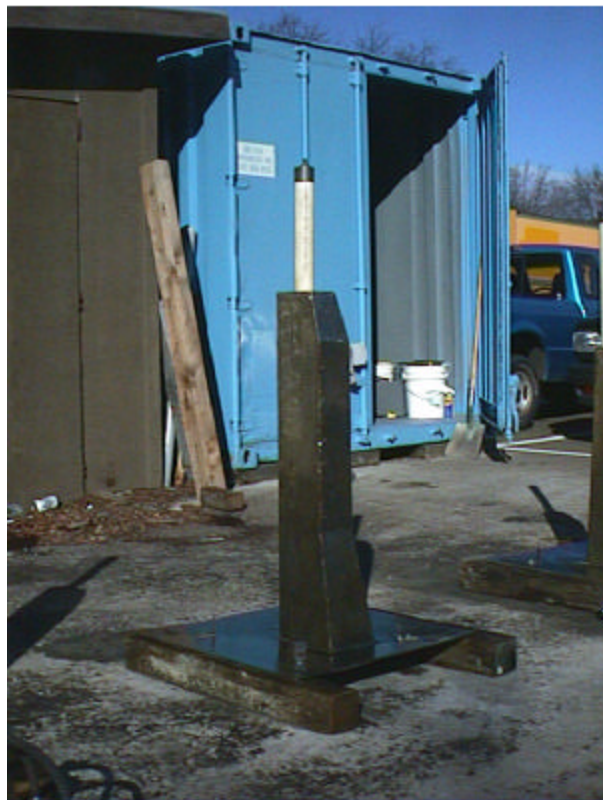
Figure 2.

Typical 4” x 6” steel cavity form bolted to the steel crown plate. Note the drain tube and special nut used to hold it in place.

A small bead of silicone was applied at the joint between the cavity form and the crown plate to prevent spalling when the form is removed. The crown plate center was bowed approximately $\frac{1}{2}$ ” lower than its sides. This produced a $\frac{1}{2}$ ” high crown on the finished footing which would help prevent pooling of rain water around the base of the signpost and thus help reduce the possibility of swelling of the signpost. Two #5 rebar hoops were welded to two 6” long pieces of #5 rebar and two $\frac{3}{4}$ ” ferrule loop inserts. The insert mounting plugs were then used to secure the hoops and inserts to the steel crown plate. This method removed the need for placing these items into the fresh concrete and also allowed for better control over proper placement, see Figure 3.

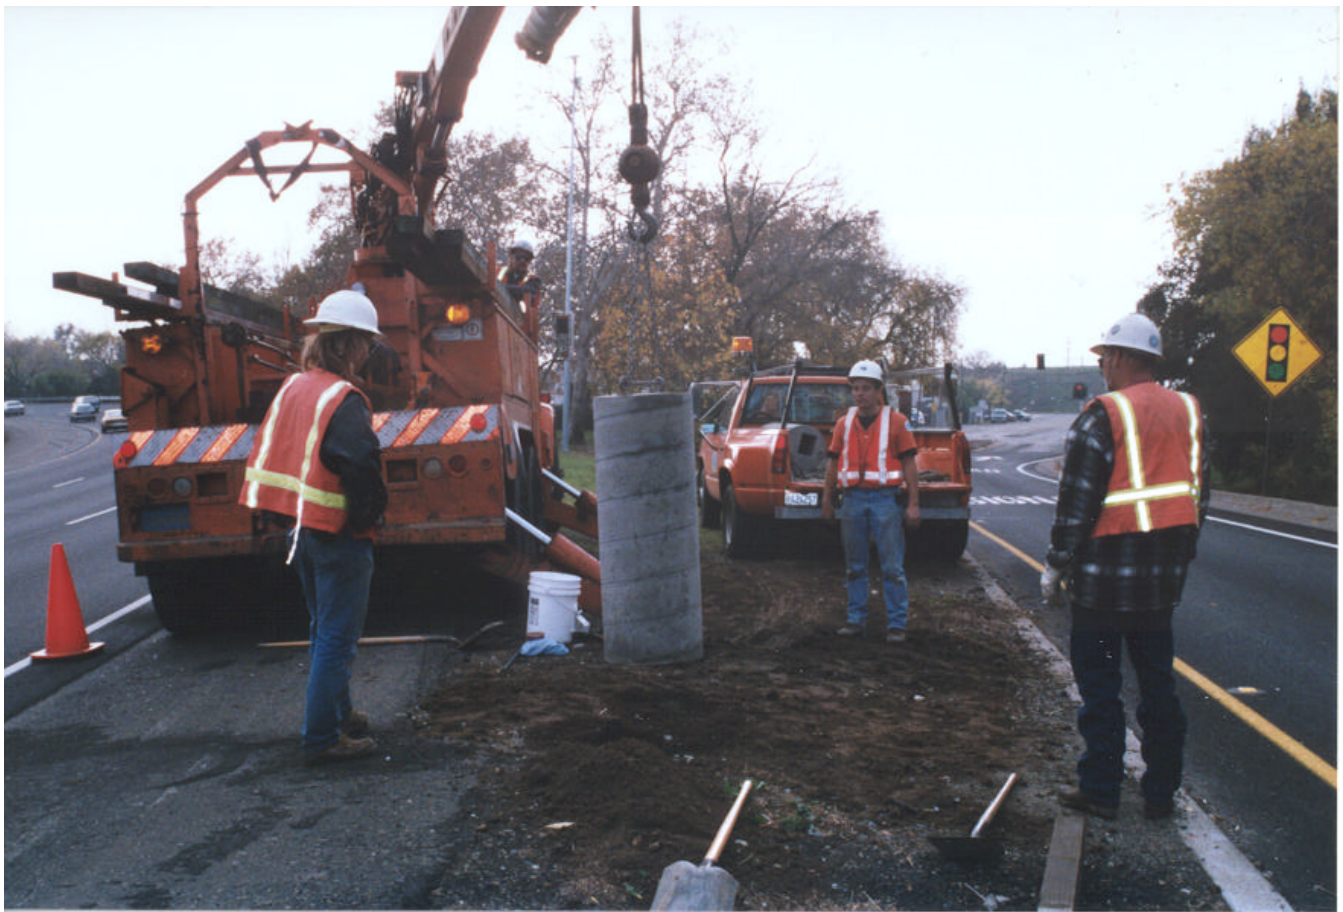
Figure 7. Lowering the footing into the augered hole.

9. Lower the footing into the hole taking care not to knock an excessive amount of native soil into the hole, see Figure 7. Before the footing is lowered completely, make sure the embossed arrow on the top surface of the footing is pointing in the same direction as traffic flow. This is to ensure proper orientation of the wedges.
